N2537V

Following are the photos
from the re-skinning of the
rudder assembly

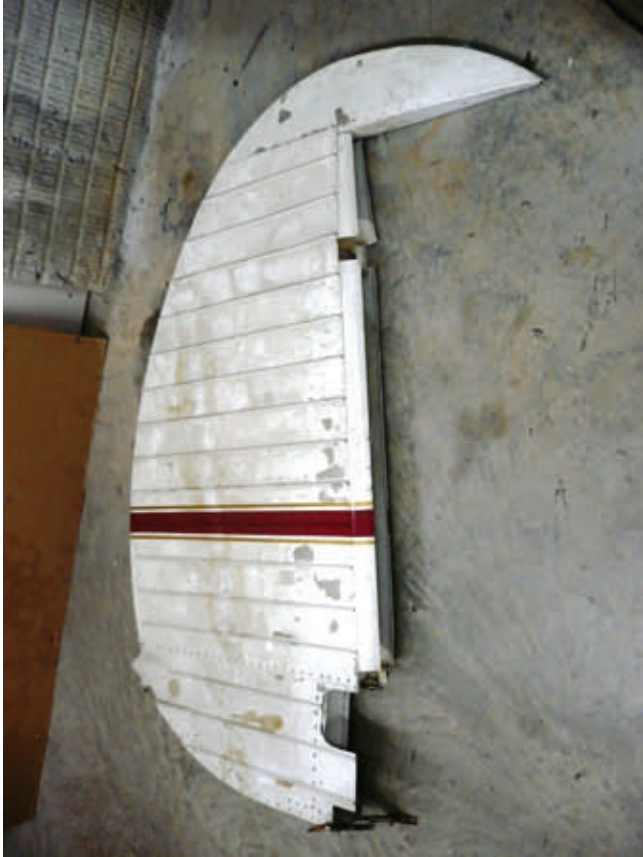
This was the condition of the rudder before drilling out the rivets and removing the skins.

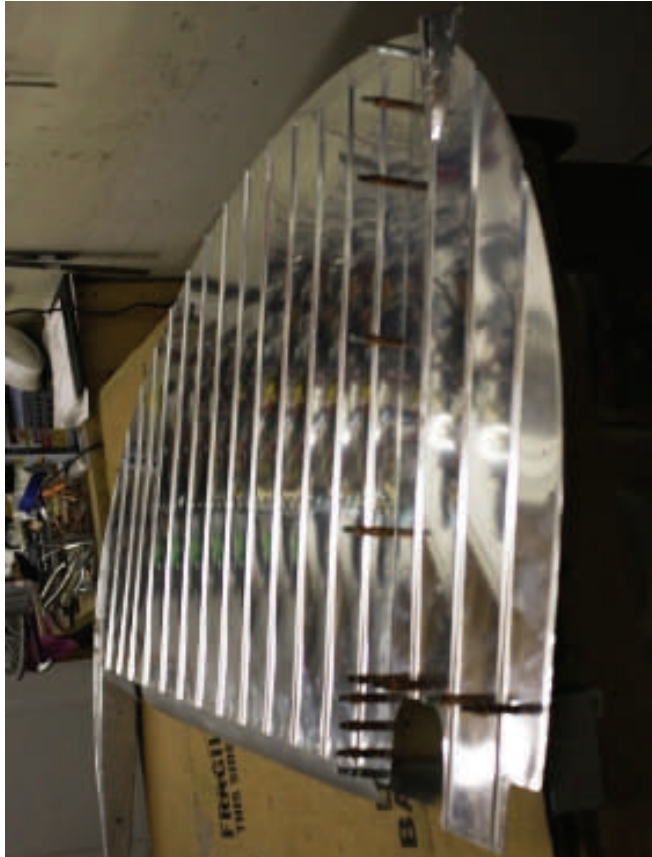
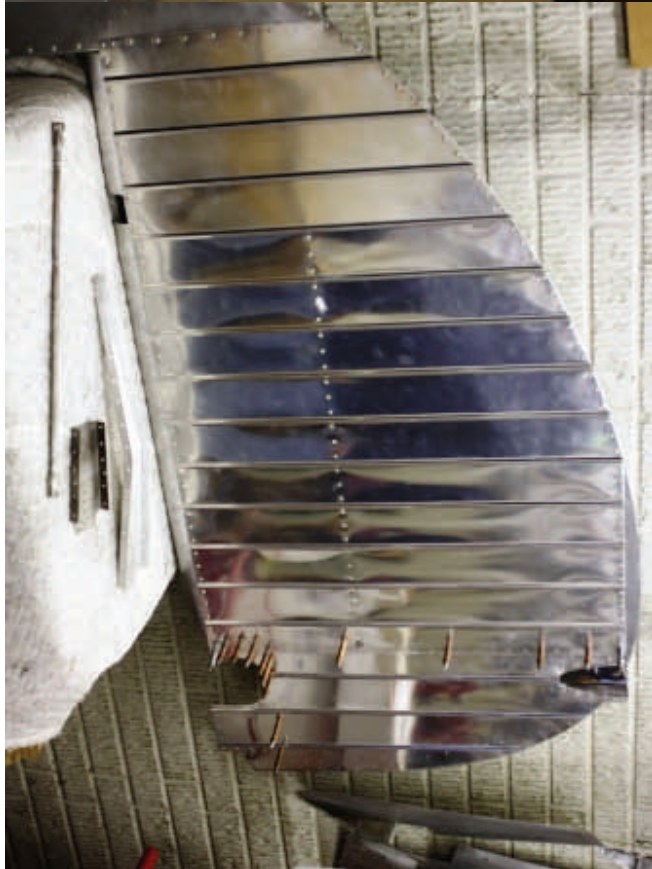
The trailing edge and around the tail light housing were originally spot welded. I was not able to get a repeatable and secure spot welds so I decided to rivet the replacement skins.

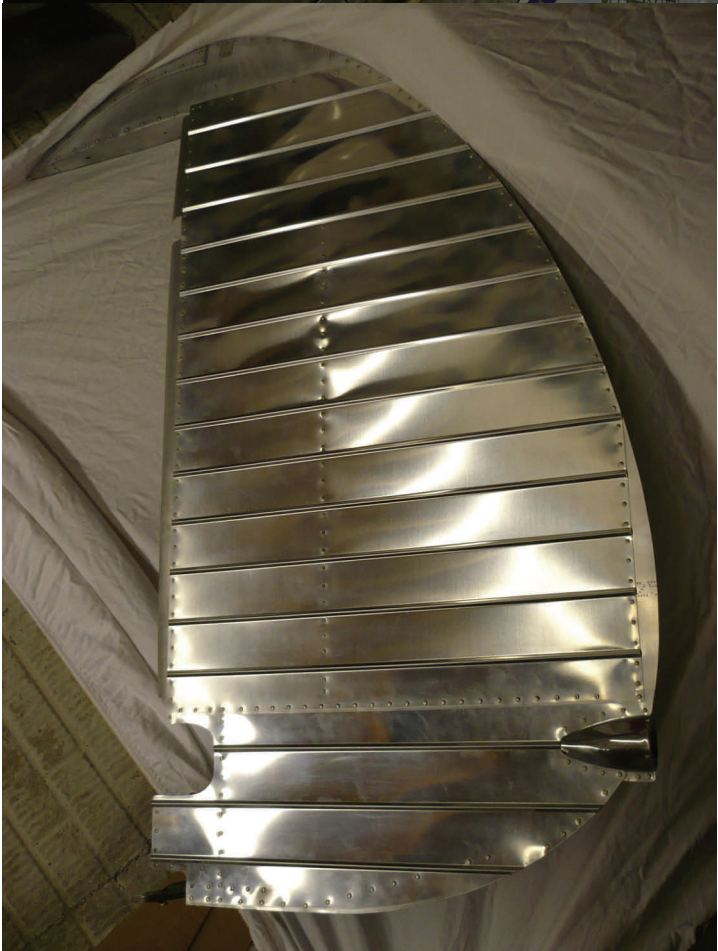
Here is the finished rudder on 1/31/2010
