N2537V

Following are the photos
from the re-skinning of the
vertical stabilizer

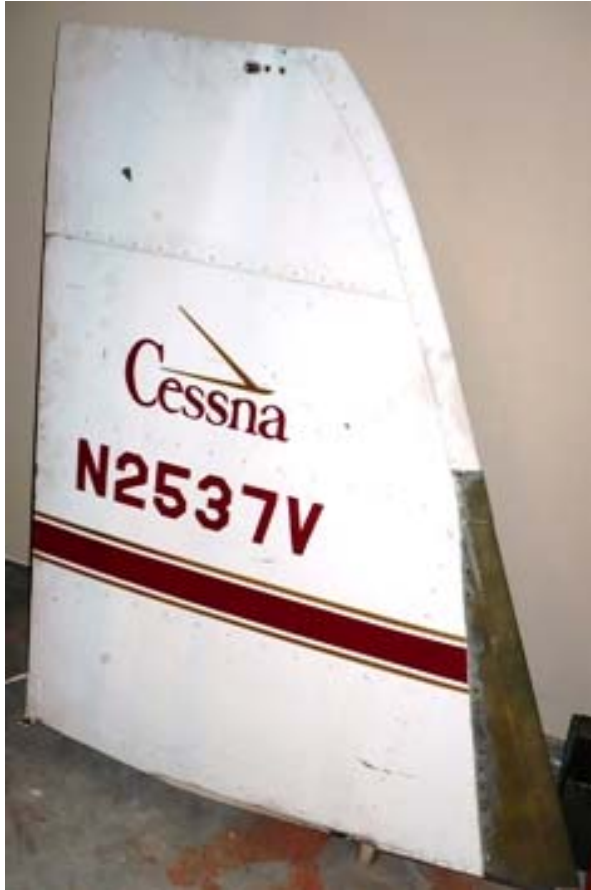
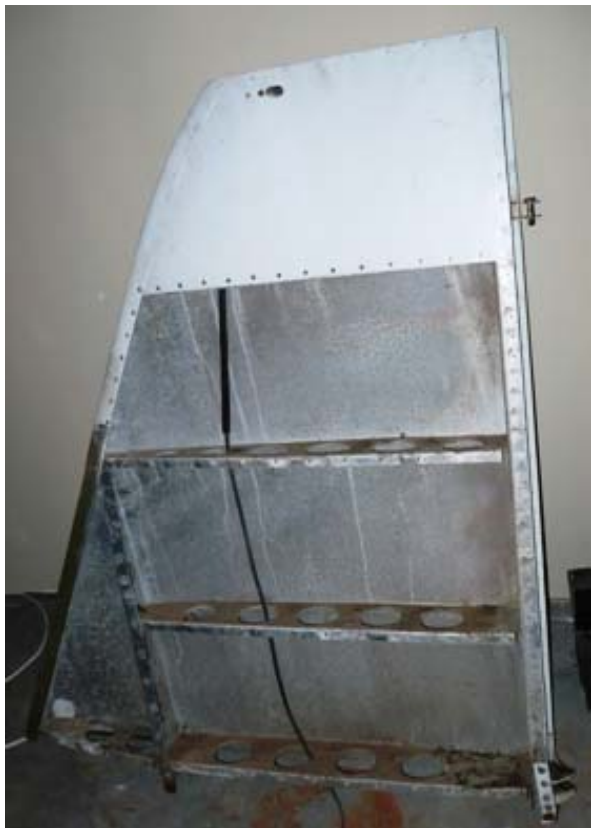
In 1966 when the airplane was painted, a Dorsal Fin was added. Since the original 1948 170 did not have the dorsal, it was removed during restoration. The addition of the dorsal made it necessary to re-skin the vertical stabilizer.

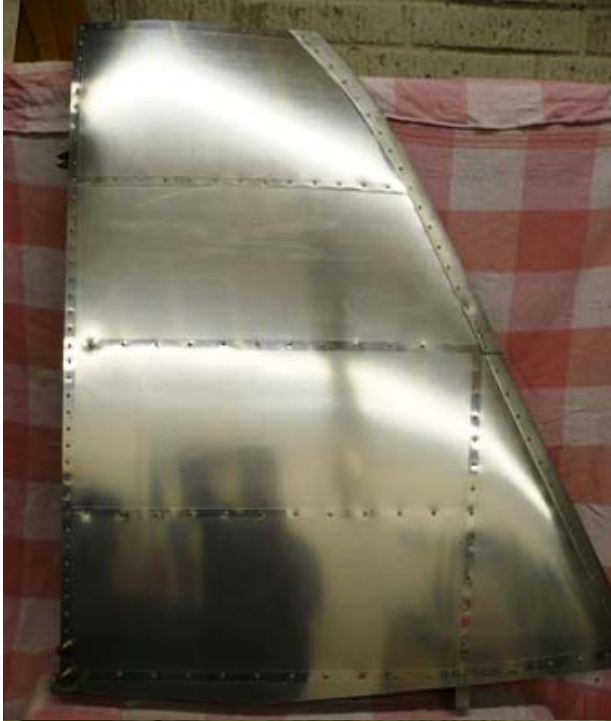
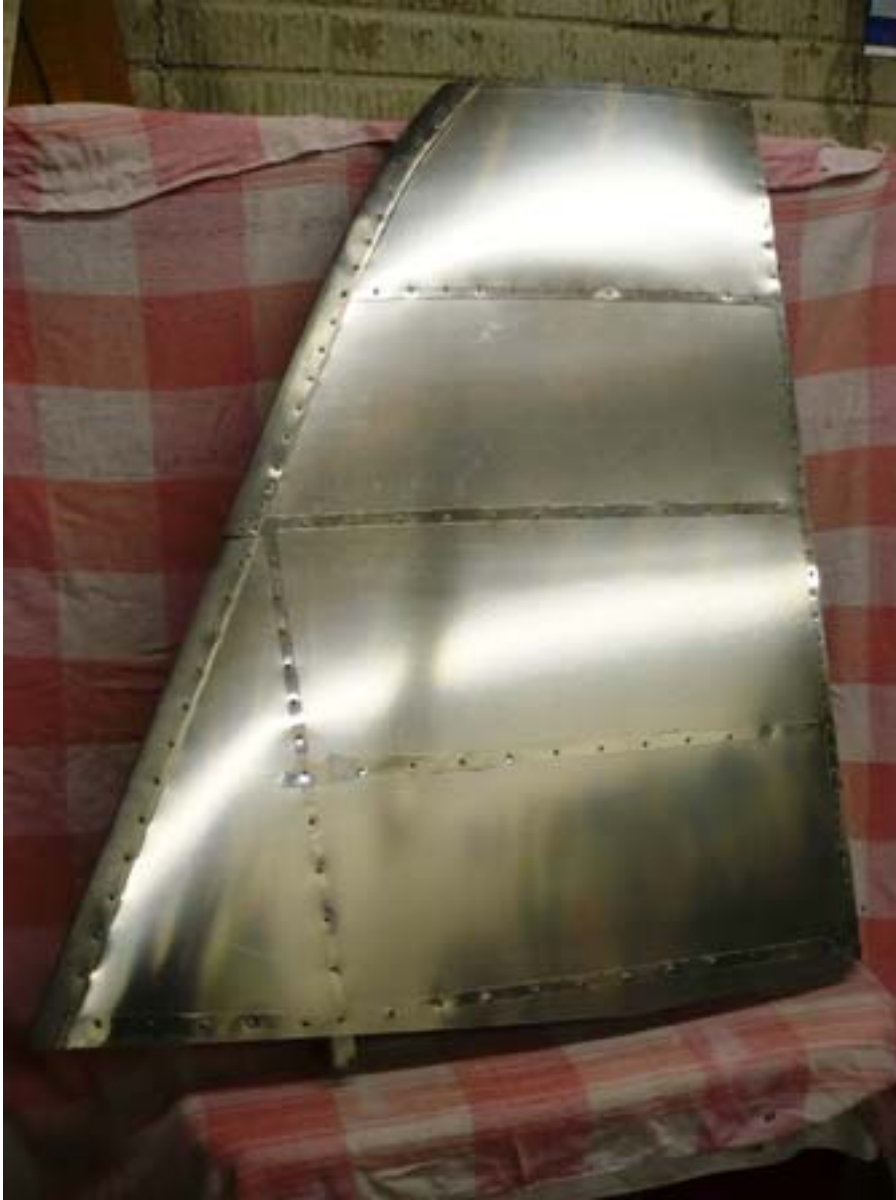
2024T3 Kaiser
Lot #
438002A8 .025
thick aluminum
was used and
attached with
AN455AD3-5
brazier head
rivets which were
originally used

Structural rivets
AN442AD sizes 4
and 6 are used
